**Flood Control Project Maintenance
Levee Inspections**
LMA District Cover Sheet
Spring 2015 Levee Inspection Results

Levee Inspection Report By Mile - Spring 2015

Waterway	Bank	Unit Miles	Inspection Start/End	Inspector
Unit No. 01 Feather River West Levee-Nelson Bend		0.50	05/14/2015 05/14/2015	Michael Pitta

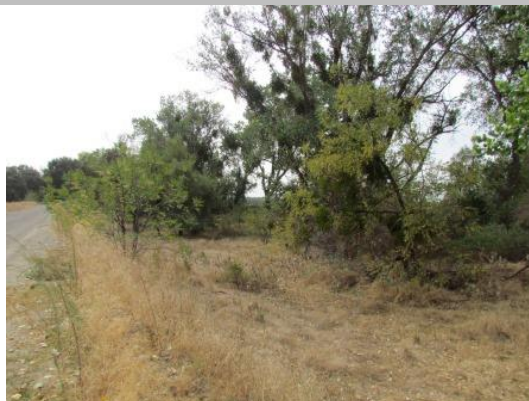
Photo 1 of 1 : SP_2015_ST0006_471_3_20150401_00002.jpg

LM Start	0.01	Rating **	M	Issue No.	3
LM End	0.45	Issue Type +	Ma	Location *	LS
Category	Earthen Levee			GPS Latitude/Longitude	
				Start	End
Item	Trim / Thin Trees			38.886925 °	38.880914 °
				-121.614752 °	-121.614428 °
DWR ID	DWR_ST0006_01_s _ 2012_3				
Action/Comments					
Thin trees to allow visibility of the ground and room to flood fight.

This photo was taken from the crown facing south looking down the landward levee slope at trees that need to be trimmed up 5 feet to allow for slope visibility. Fall 2014.

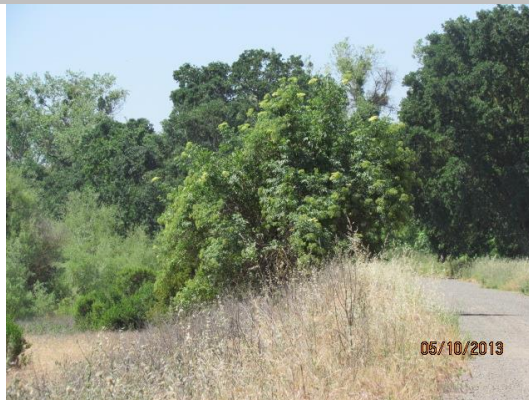
Photo 1 of 1 : SP_2015_ST0006_471_4_20150401_00003.jpg

LM Start	0.06	Rating **	M	Issue No.	4
LM End	0.06	Issue Type +	Ma	Location *	WS
Category	Earthen Levee			GPS Latitude/Longitude	
				Start	End
Item	Vegetation			38.886277 °	38.886277 °
				-121.615129 °	-121.615129 °
DWR ID	DWR_ST0006_01_s _ 2012_4				
Action/Comments					
Elderberries are blocking visibility and flood fight capability.

View of the elderberries that are blocking visibility.
